# UNDERWATER BRIDGE INSPECTION REPORT

STRUCTURE NO. 31509  
CSAH NO. 63  
OVER THE  
MISSISSIPPI RIVER  
DISTRICT 1 - ITASCA COUNTY

PREPARED FOR THE  
MINNESOTA DEPARTMENT OF TRANSPORTATION  
BY  
COLLINS ENGINEERS, INC.  
JOB NO. 5221 (CEI 28)

MINNESOTA DEPARTMENT OF TRANSPORTATION  
UNDERWATER BRIDGE INSPECTION

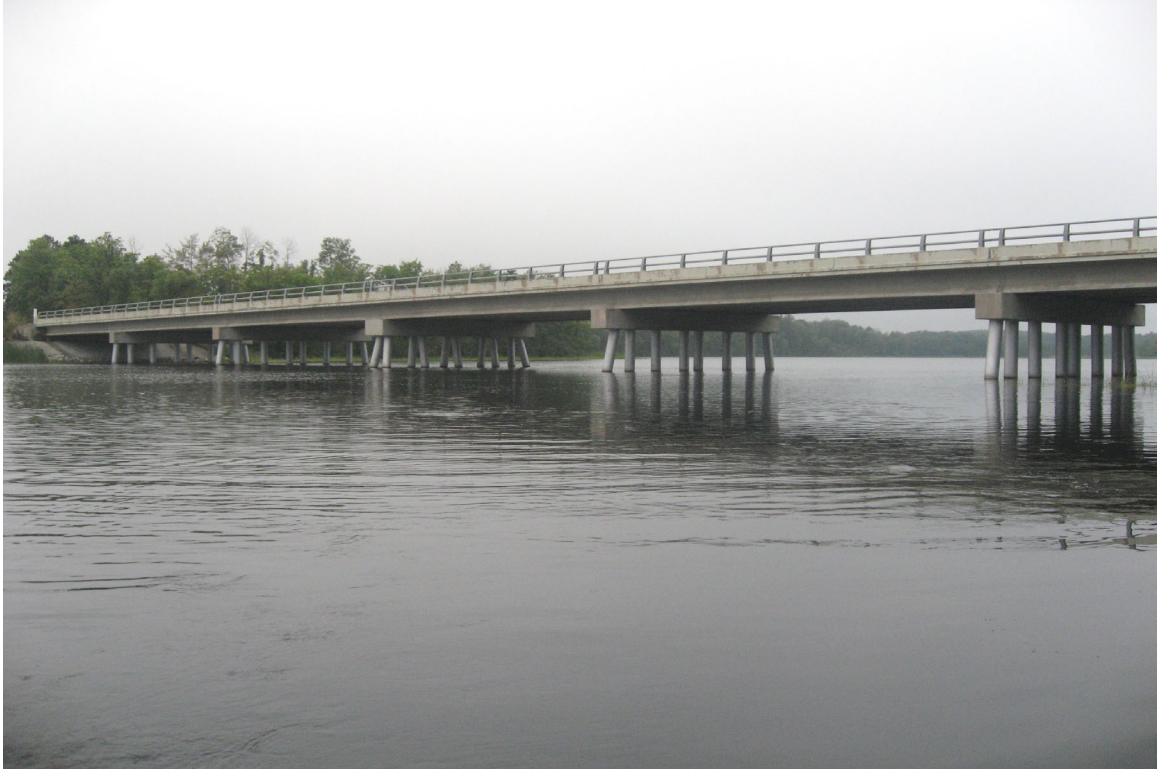
Photograph 1. Overall View of the Structure, Looking Northwest.

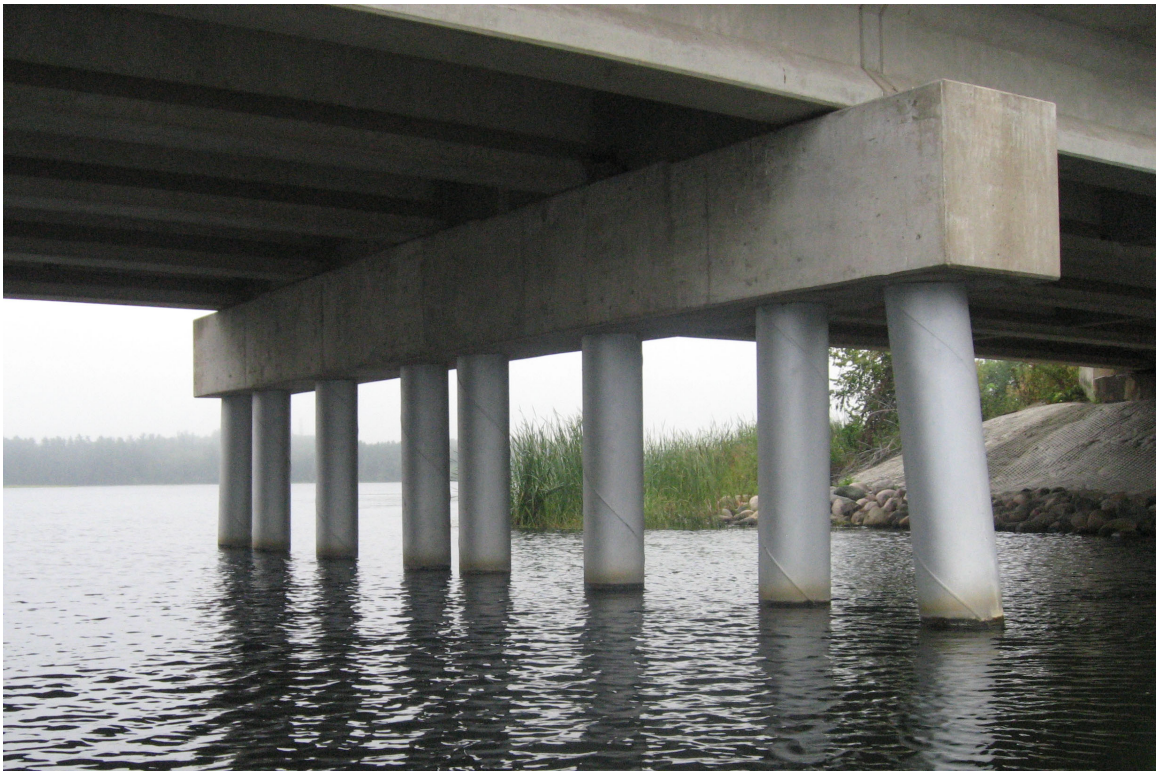
Photograph 2. View of Pier 1, Looking North.

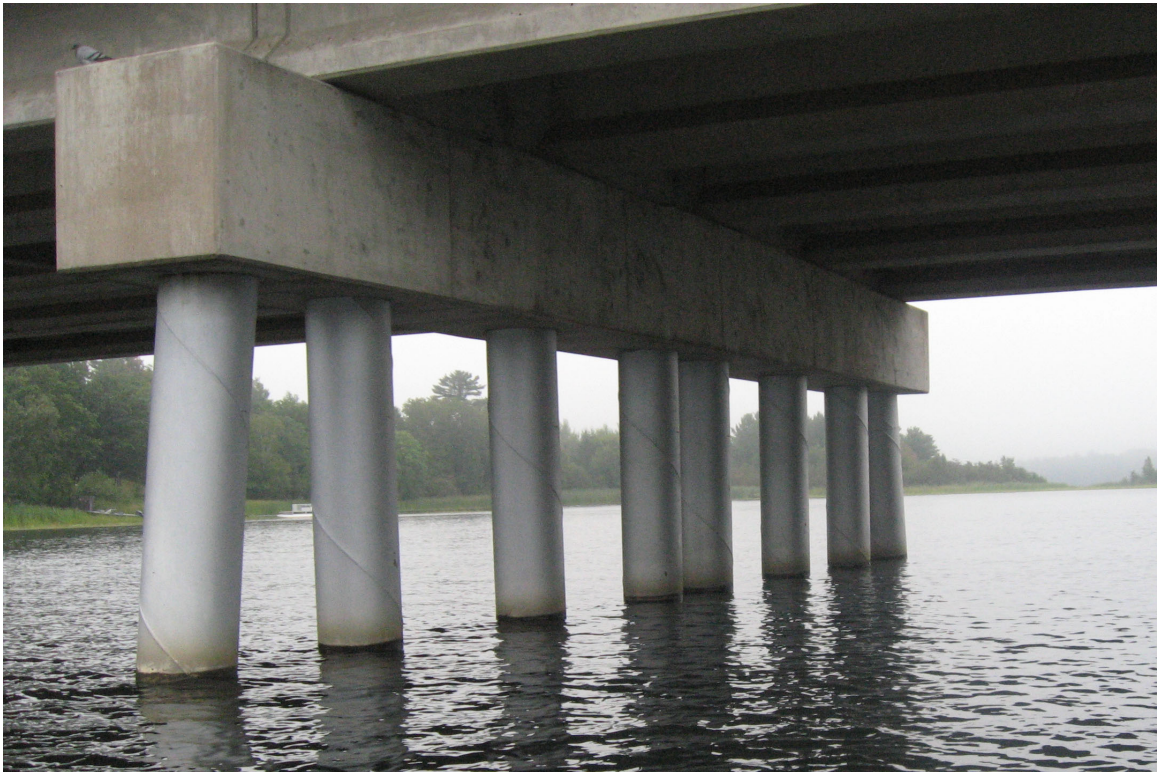
Photograph 3. View of Pier 2, Looking Southeast.

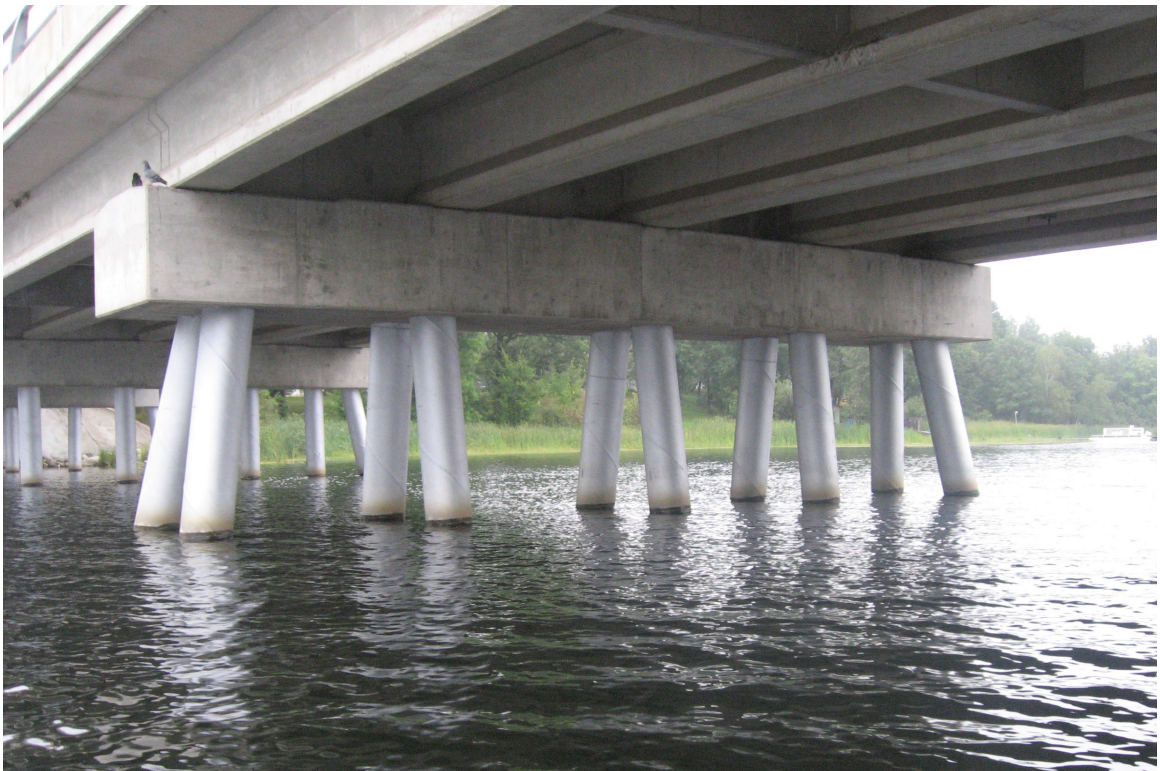
Photograph 4. View of Pier 3, Looking Southeast.

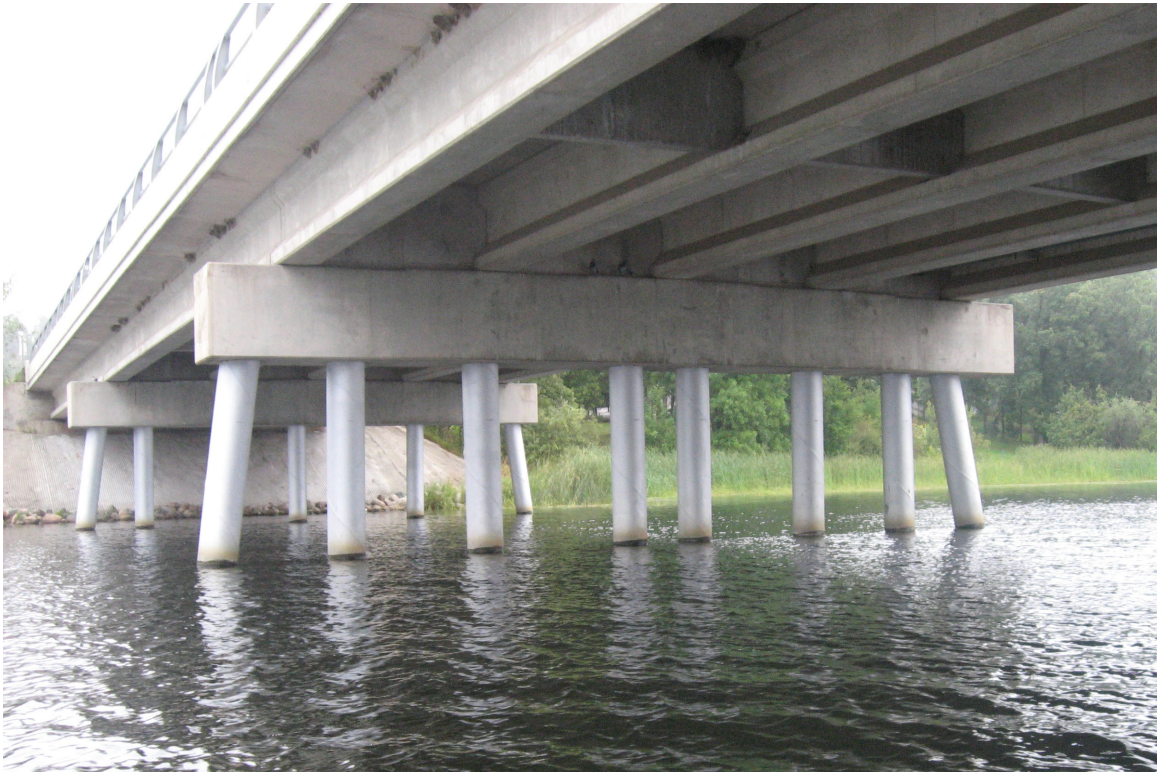
Photograph 5. View of Pier 4, Looking Southeast.

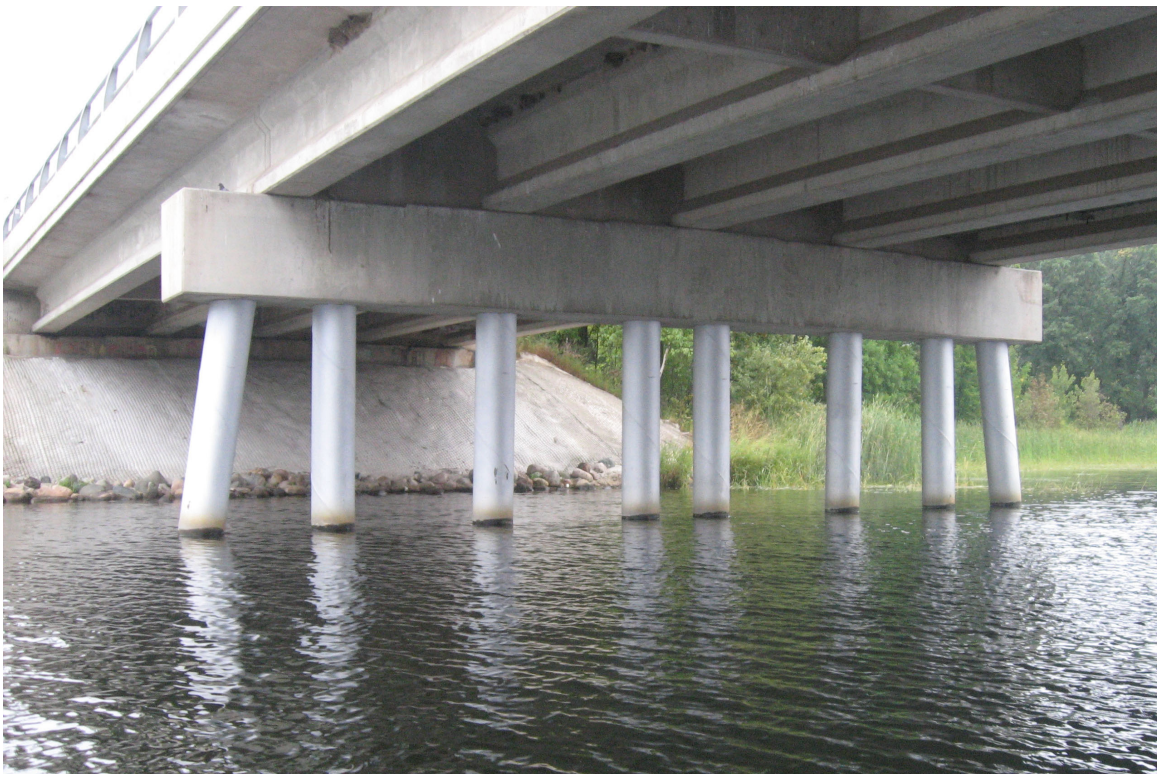
Photograph 6. View of Pier 5, Looking Southeast.

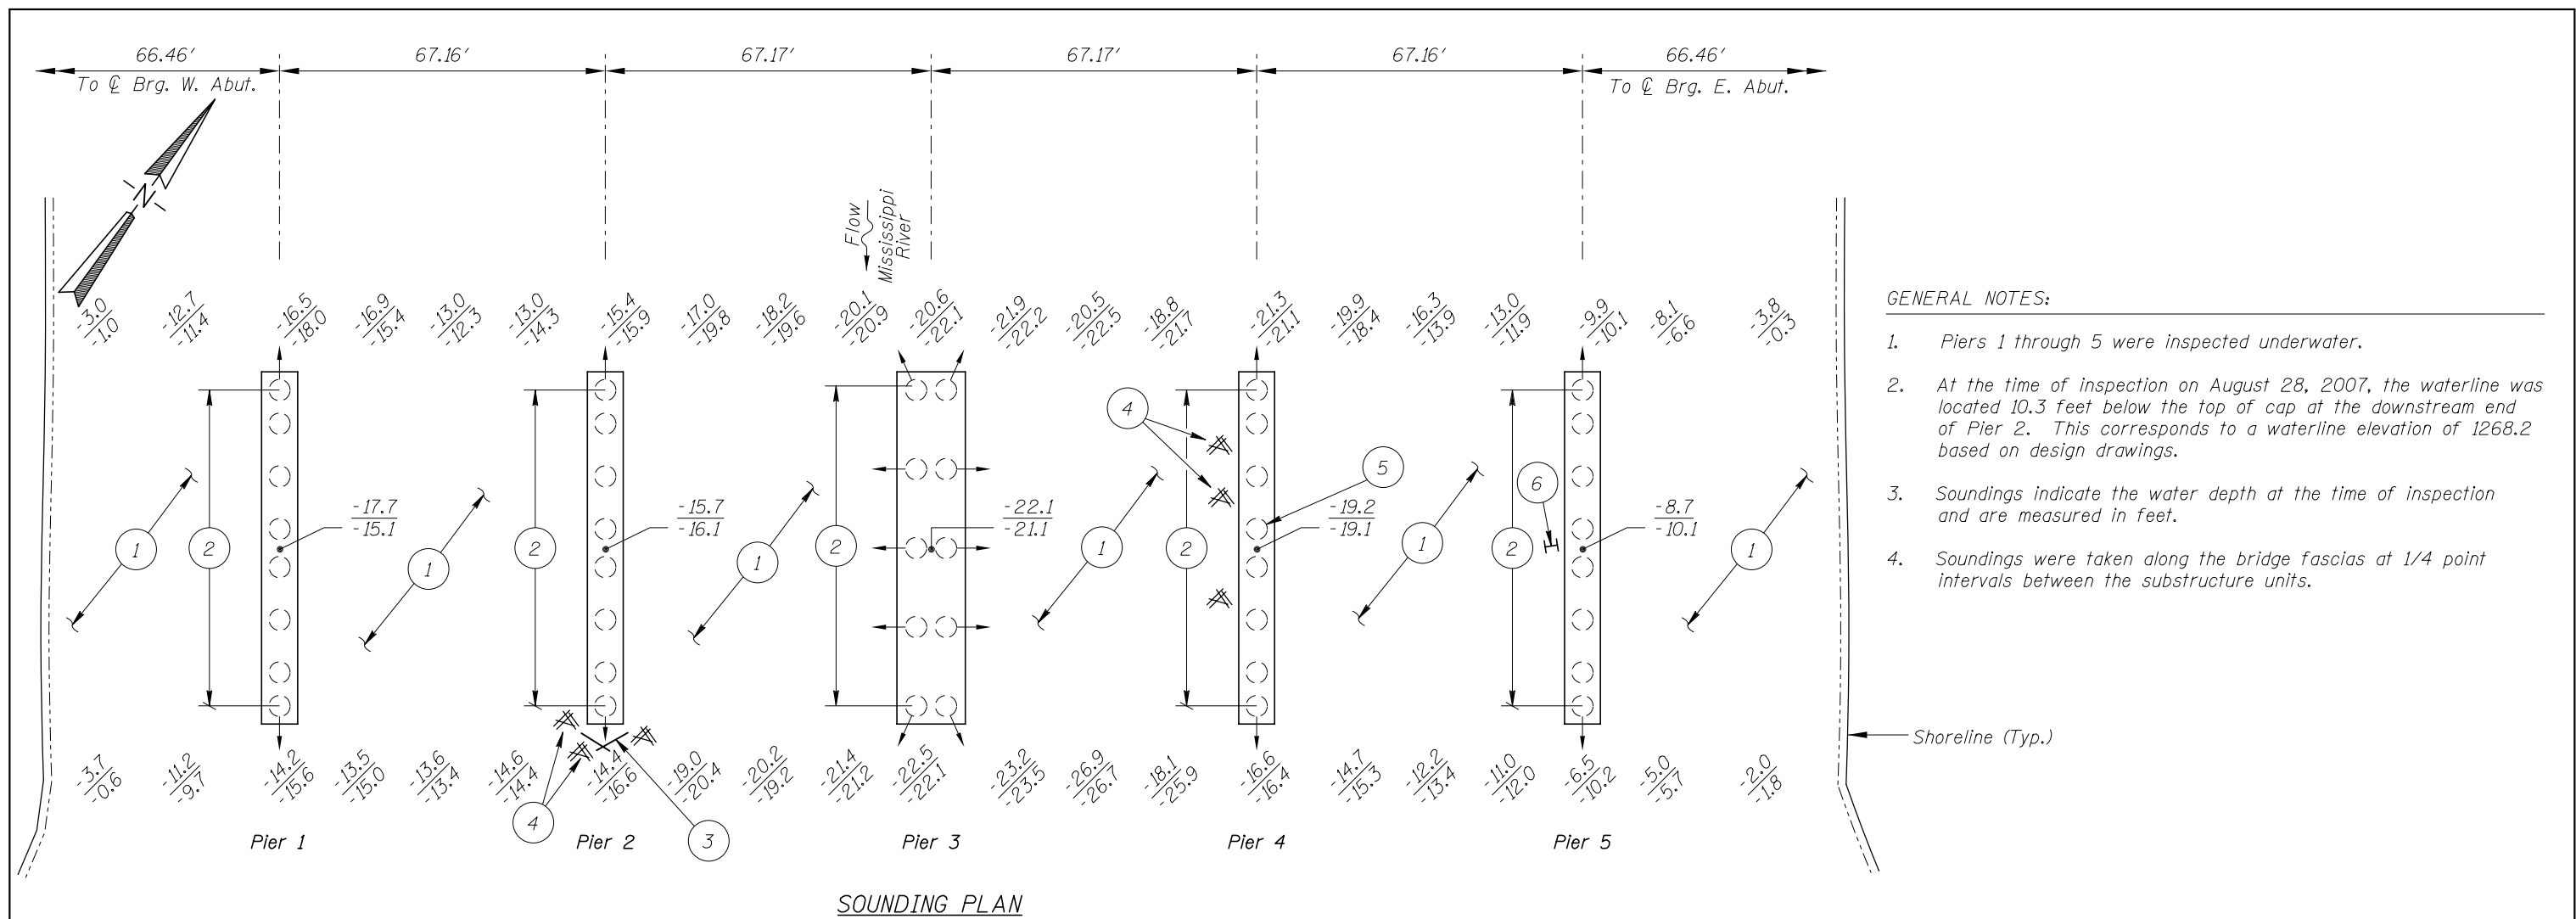
**SOUNDING PLAN**

- Channel bottom consists of soft silty sand with gravel and cobbles, with up to 6 inches of probe rod penetration.
- Coating failure, corrosion, and rust nodules, were observed from 6 inches above the waterline to the channel bottom on approximately 80 to 100 percent of the surface area of all piles. Typical pitting penetrations of the rust nodules were 1/32 inch, with infrequent instances of 1/16 inch and 1/8 inch penetrations observed on the steel shell piles.
- Large steel plate debris.
- Timber drift consisting of 1 foot diameter and smaller logs observed at the mudline.
- 3/4 inch diameter steel cables were observed to be wrapped around the pile.
- A steel H-pile was sticking 8 feet out of the channel bottom and angled toward the downstream.
